## INTERNATIONAL JOURNAL FOR ENGINEERING APPLICATIONS AND TECHNOLOGY

### “A REVIEW PAPER ON BOILER TUBES FAILURE: CAUSES & REMEDIES”

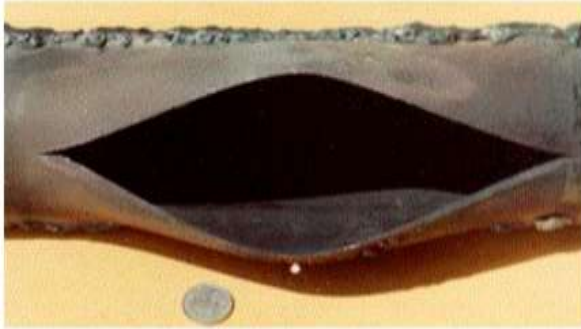
reported leakage [5] on the bottom tube just above the economizer of this coil in segment-B. During analysis, it was found that failure occurred because of erosion caused by ash passing between this tube & skin casing. Around one meter length of the tube had severe thinning because of this erosion. Also the tube just above this tube in the same coil had severe thinning. Then the coil was plugged with alloy steel taper plugs on both the headers using E-8018 electrodes.

**Fig. 1. Import Steam Super Heater Tubes of Boiler SGP NFL Naya Nangal.**

Superheater Fireside Ash Corrosion resulted in external tube wall loss and increasing tube strain. Tubes commonly have a pock-marked appearance when scale and corrosion products are removed. Fireside ash corrosion is a function of the ash characteristics of the fuel and boiler design. It usually is associated with coal firing, but also can occur for certain types of oil firing. Ash characteristics are considered in the boiler design when establishing the size, geometry and materials used in the boiler. Combustion gas and metal temperatures in the convection passes are important considerations. Damage occurs when certain coal ash constituents remain in a molten state on the superheater tube surfaces. This molten ash can be highly corrosive

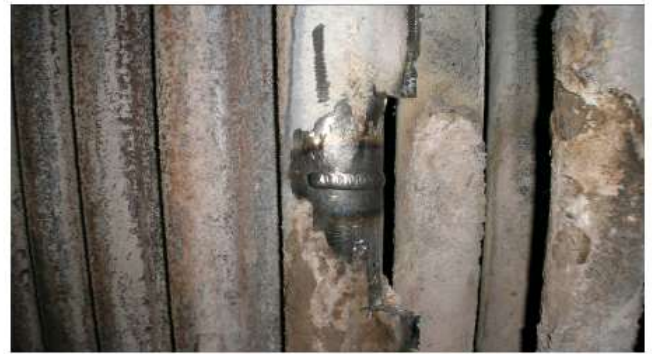
On 10.11.2005 water leakage was detected in the economizer tubes in the south east side of the coils [5]. The boiler was shut down for maintenance. After opening the manhole & entering the economizer top following observations were recorded: 25th coil, 2nd loop top SN between segment C&D is having 3mm diameter hole and also eroded 3 inch in length. Due to the impingement of the above leaky coil on coil No 24, first loop bottom length all around & 4 inch in length was found heavy reduction in thickness. NDT testing of surrounding tubes was done and reduction in thickness was observed

Aggressive localized corrosion and loss of tube wall, most prevalent near economizer feed water inlet on operating boilers. Flooded or non-drainable surfaces are most susceptible during outage periods. Oxygen pitting occurs with the presence of excessive oxygen in boiler water. Non-drainable locations of boiler circuits, such as super heater

**Fig. 2. Economizer Tubes of Boiler-I SGP NFL Naya Nangal.**

loops, sagging horizontal superheater and reheater tubes, and supply lines, are especially susceptible. More generalized oxidation of tubes during idle periods is sometimes referred to as out-of-service corrosion. Wetted surfaces are subject to oxidation as the water reacts with the iron to form iron oxide. When corrosive ash is present, moisture on tube surfaces from condensation or water washing can react with elements in the ash to form acids that lead to a much more aggressive attack on metal surfaces

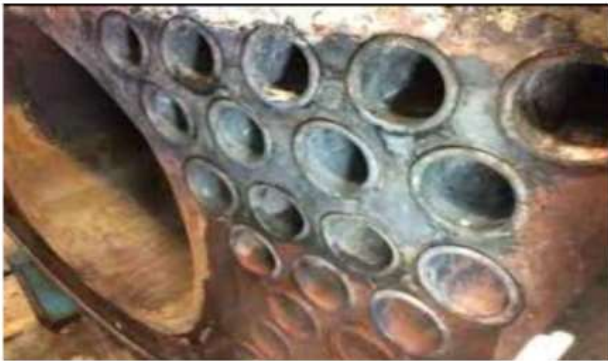
observations are 8th row (W-E) and tube No 4(N-S) in the north cluster were completely open [5]. Skin casing was cut and removed and observed that leakage was at the outlet of the steam drum. This leakage had also damaged the 7th tube in the same cluster due to impingement of water. After scanning the tube it was decided to plug the tubes ends.

Failure of the first tube was contributed to the leakage travel between tube outer diameter and tube sheet internal diameter. The small pinhole in the weld joint is responsible for the leakage of the other tubes. The photographs of the damaged tube are given below. Stress corrosion cracking failures were observed as in a thick wall, brittle-type crack at location of higher external stresses, such as near joints

**Fig. 4. Plugging of Bank Tubes of Boiler-II SGP NFL Naya Nangal.**

was observed. These failures are associated with austenitic super heater materials and can lead to either transgranular or intergranular crack propagation in the tube wall. It occurs where a combination of high-tensile stresses and a corrosive fluid are present. The damage results from cracks that propagate from the ID. The source of corrosive fluid may be carryover into the superheater from the steam drum or from contamination during boiler acid cleaning if the superheater is not properly protected. Combustion gas and metal temperatures in the convection passes are important considerations. Damage occurs when certain coal ash constituents remain in a molten state on the superheater tube surfaces. This molten ash can be highly corrosive and eroded the surface of boiler tubes. The Combined effect leads to the breakdown of the protective magnetite on the ID surface of the boiler tube. The loss of this protective scale exposes tube to corrosion.
